HLHL sorgt für den guten Ablauf
www.hl.at**TÜV**
AUSTRIAZERTIFIZIERT
EN ISO 9001
ZERTIFIKAT NR. 20 100 8085
TÜV AUSTRIA CERT GMBH**HL68H.0/50** DN 50 0,45 l/s EN1253

DE ATTIKABLAUF MIT BITUMENMANSCHETTE
 BG БАРБАКАН С БИТУМЕН МАНШЕТ
 CS/SK ATIKOVÝ ODTOK S ASFALTOVOU MANŽETOU
 EN ATTICA DRAIN WITH BITUMEN MEMBRANE
 HR ATIKA SLIVNIK SA BITUMENSKOM PRIRUBNICOM
 HU ATTIKALEFOLYÓ BITUMENGALLÉRRAL

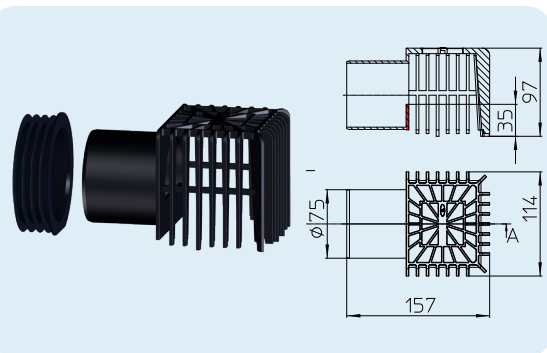
HL068.1Safe

EN LEAF CATCHER „EMERGENCY DRAINAGE“
